Methods for Determining Moisture in Fiberglass Hulls

By Captain John Banister, SA Suenos Azules Marine Surveying and Consulting

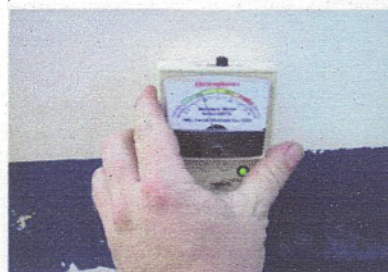
Moisture meter readings on the hull of a sailboat

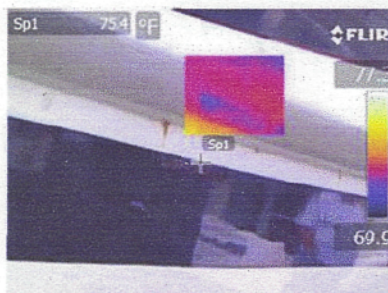
"Picture in picture" thermal imaging on trapped water near the chine on a fiberglass power boat

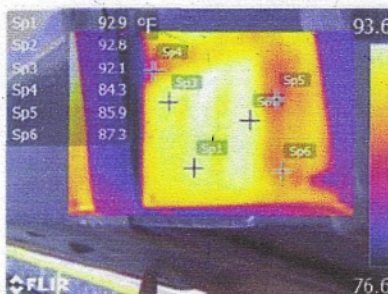
"Picture in picture" thermal image of a fiberglass patch under the gel coat with residual trapped water around the patch

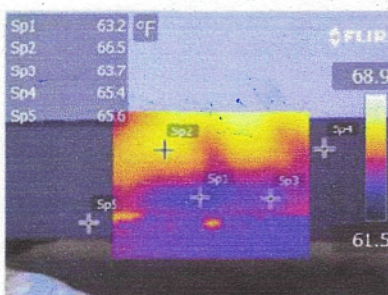
Trapped water under the fiberglass near the hull bottom (no blistering was seen yet)
